Manhole Inspection Summary

Manhole # S5100_004MH

Insp Date: **6/24/08 1:46 PM**

Location Address: **Elmora**

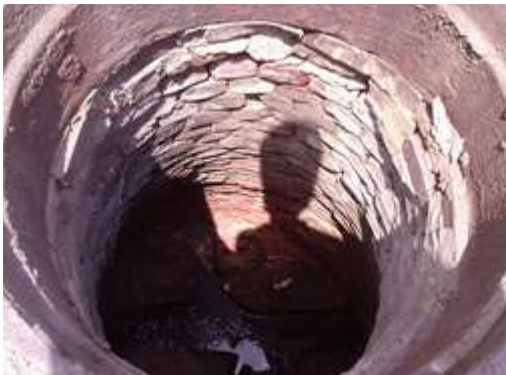
Defect 2

Infiltration: ☐ None ☒ **Joint** ☐ Cracks ☒ **Mortar** ☐ Roots ☐ Wall

Adjustment joint

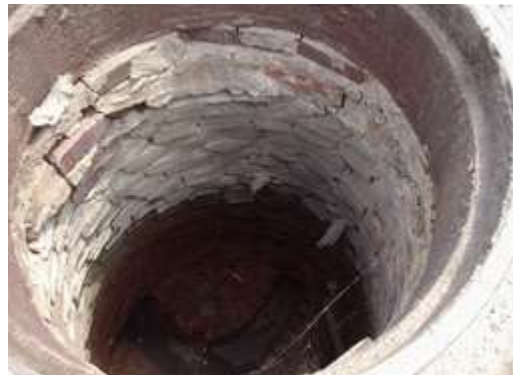
Defect 1

Condition: ☐ Sound ☐ Cracked ☐ Root Intrusion ☒ **Loose Brick** ☐ Deteriorated

Loose bricks

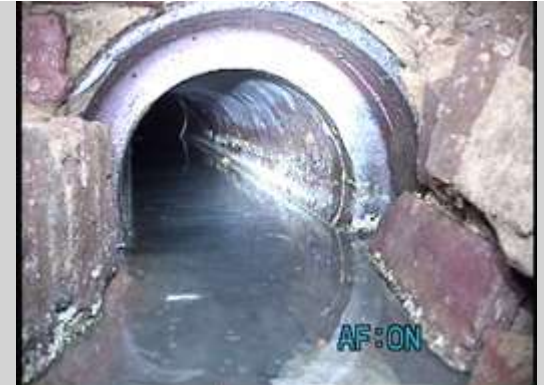
12 O'Clock Outflow

10 in. Circular Gravity Sewer
Pipe Out @ 12 O'Clock

Pipe Height: **10.8** (in.) Rod and Bar (Angled)
Pipe Material: **Clay** ☐ Pipe Lined
Invert Depth: **7.80** (ft.) Flow Characteristics: **Slow**
Deposits: ☒ None ☐ Mud ☐ Sludge ☐ Debris ☐ Grease
Silt Depth: (in.) Deposits Extent:
Infiltration: **None** Pipe Seal Cond: **Sound**

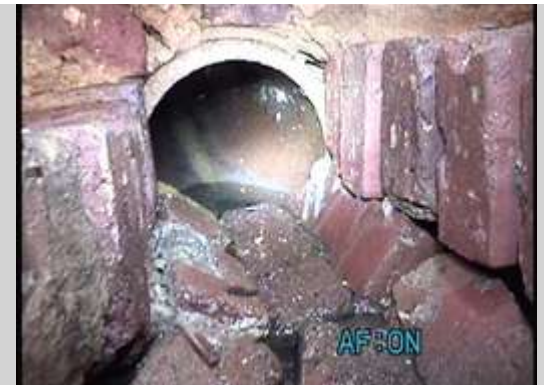
3 O'Clock Inflow

6 in. Circular Gravity Sewer
Pipe In @ 3 O'Clock

Pipe Height: **6** (in.) Rod and Bar (Angled)
Pipe Material: **Clay** ☐ Pipe Lined
Invert Depth: **7.60** (ft.) Flow Characteristics: **Slow**
Deposits: ☒ None ☐ Mud ☐ Sludge ☐ Debris ☐ Grease
Silt Depth: (in.) Deposits Extent:
Infiltration: **None** Pipe Seal Cond: **Sound**

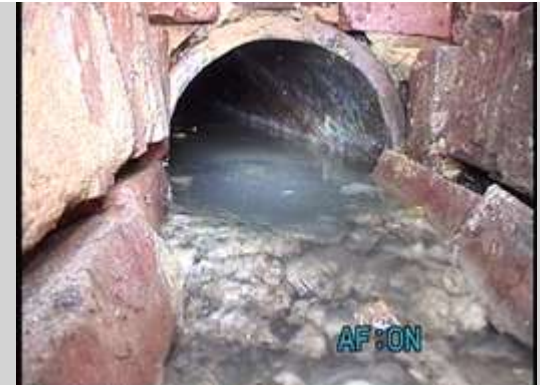
6 O'Clock Inflow

Pipe Height: **10.8** (in.) Rod and Bar (Angled)

Infiltration: **None** Pipe Seal Cond: **Sound**

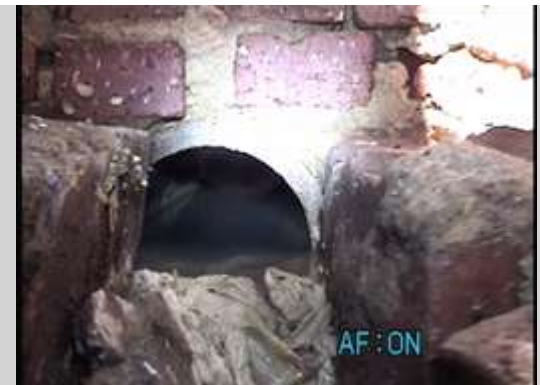
9 O'Clock Inflow

Pipe Height: **6** (in.) Rod and Bar (Angled)

Infiltration: **None** Pipe Seal Cond: **Sound**
